**Flood Control Project Maintenance
Levee Inspections****LMA District Cover Sheet****Spring 2013 Levee Inspection Results****Sutter Maintenance Yard Tisdale Bypass**

Levee Inspection Report By Mile - Spring 2013

Sutter Maintenance Yard Tisdale Bypass

Waterway				Bank	Unit Miles	Inspection Start/End	Inspector	
Unit No. 01 Tisdale Bypass				Left	4.50	03/05/2013 03/05/2013	Bob Duffey

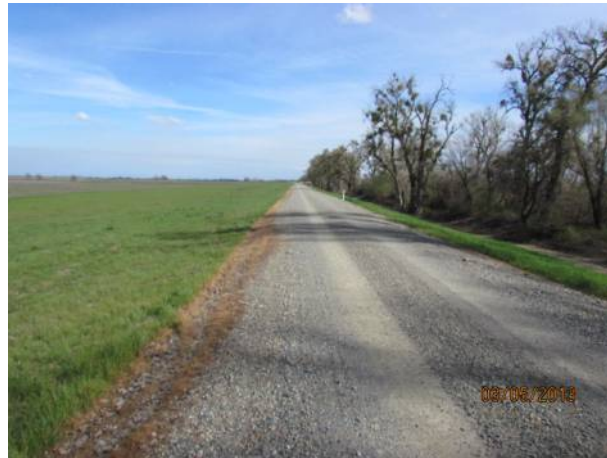
Levee Mile Report Line	4
Start Levee Mile	1.46
End Levee Mile	1.46
Location	Land Side
Category	
Item	Vegetation

View of the levee with native grasses on both slopes.

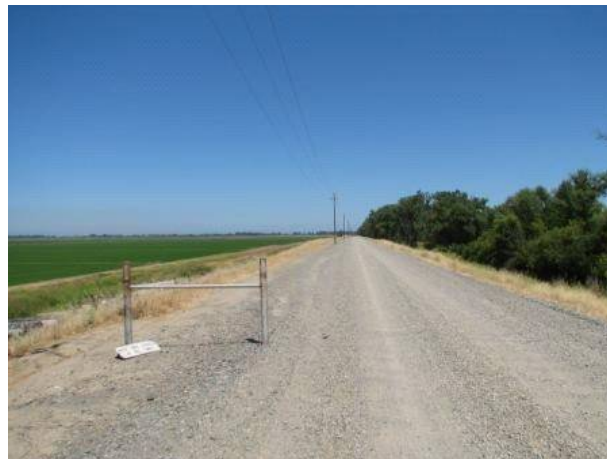
Levee Mile Report Line	5
Start Levee Mile	2.18
End Levee Mile	4.10
Location	Land Side
Category	
Item	Encroachments

View of the PG&E poles along the landside crown of the levee.

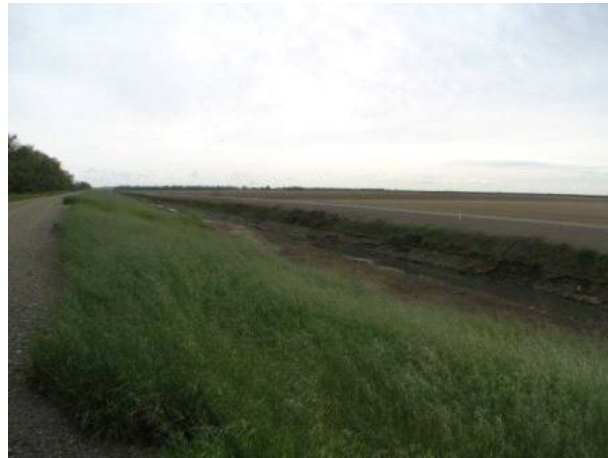
Levee Mile Report Line	1
Start Levee Mile	0.11
End Levee Mile	0.25
Location	Land Side
Category	
Item	Encroachments
View of the agriculture ditch and erosion along the landside toe of the Levee.	
rduffey_s_20130225_283.jpg

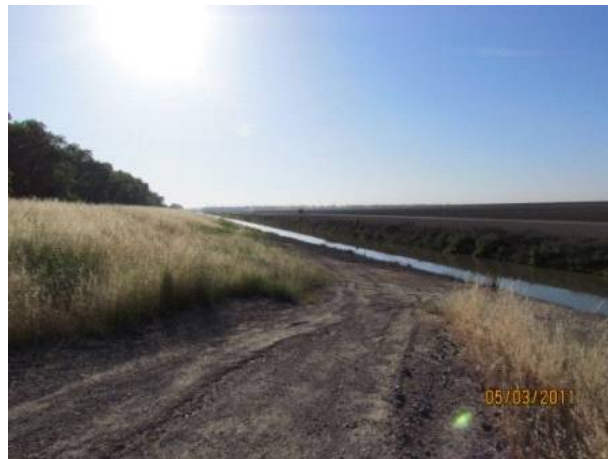
Levee Mile Report Line	2
Start Levee Mile	0.52
End Levee Mile	1.74
Location	Land Side
Category	
Item	Encroachments
View of the ag ditch next to the L/S toe.	
rduffey_s_20130225_284.jpg

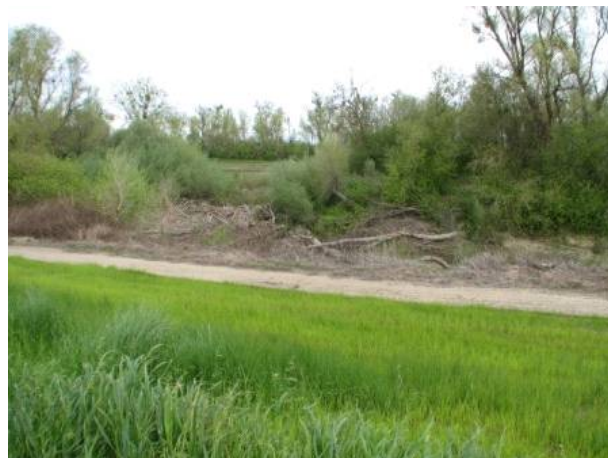
Levee Mile Report Line	3
Start Levee Mile	1.01
End Levee Mile	1.01
Location	Water Side
Category	
Item	Erosion / Bank Caving
View of the erosion along the waterside toe of the levee.	
rduffey_s_20130225_285.jpg

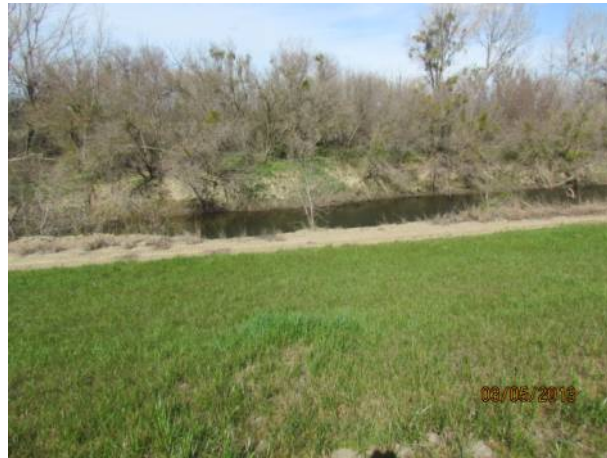
Levee Mile Report Line	4
Start Levee Mile	1.29
End Levee Mile	1.29
Location	Water Side
Category	
Item	Erosion / Bank Caving

View of the erosion along the waterside berm.

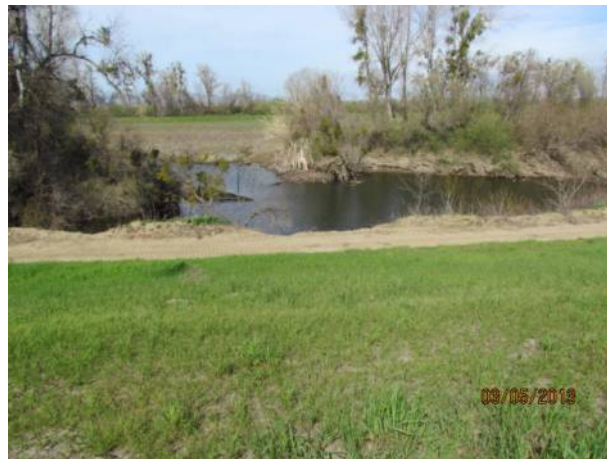
Levee Mile Report Line	5
Start Levee Mile	1.50
End Levee Mile	1.50
Location	Water Side
Category	
Item	Erosion / Bank Caving

View of the erosion along the waterside berm

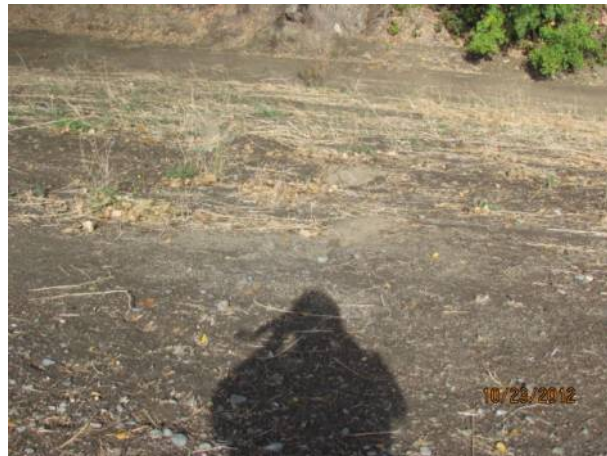
Levee Mile Report Line	6
Start Levee Mile	2.53
End Levee Mile	2.53
Location	Water Side
Category	
Item	Animal Control

View of the rodent holes along the landside slope.
